**Flood Control Project Maintenance
Levee Inspections**

Maintenance Issue Types Only, Levee Inspection Report By Mile - Spring 2019

Sutter Maintenance Yard Maintenance Area 0005

Waterway	Bank	Unit Miles	Inspection Start/End	Inspector
Unit No. 01 Butte Creek	Left	15.08	05/14/2019 05/14/2019	Makar Sokol

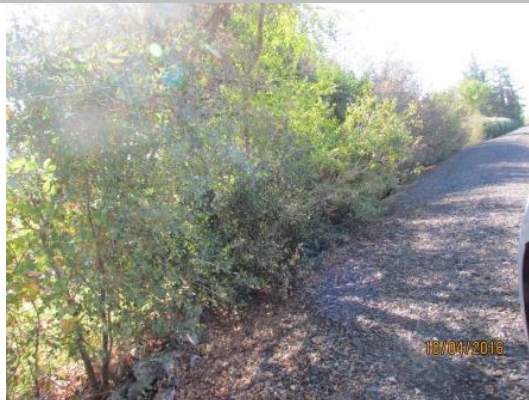
Photo 1 of 1 : SP_2019_MA0005_196_32_20190327_00012.jpg

LM Start	0.58	Rating **	M	Issue No.	32
LM End	0.68	Issue Type +	Ma	Location *	LS
Category	Earthen Levee			GPS Latitude/Longitude	
				Start	End
Item	Trim / Thin Trees			39.690496 °	39.689137 °
				-121.777109 °	-121.776938 °
DWR ID	DWR_MA0005_01_s_2014_32				
Comment Code					
T2 : Thin trees to allow visibility of the ground and room to flood fight.					
Inspector Comment					
Trees smaller than 4-inches in diameter at chest height shall be removed from the landside slope and within ten feet of the landside toe.

View of the trees along the landside toe blocking visibility.

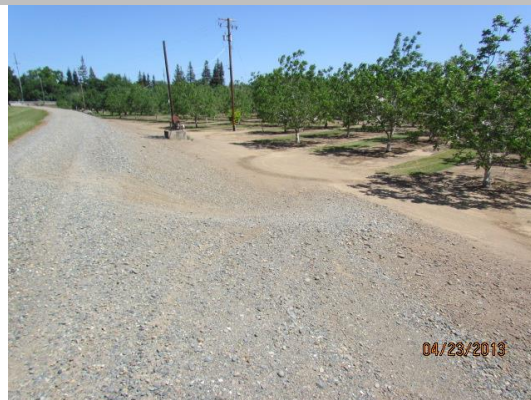
Photo 1 of 1 : SP_2019_MA0005_196_16_20190327_00006.jpg

LM Start	1.61	Rating **	M	Issue No.	16
LM End	1.61	Issue Type +	Ma	Location *	LS
Category	Earthen Levee			GPS Latitude/Longitude	
				Start	End
Item	Slope Stability			39.676129 °	39.676129 °
				-121.778171 °	-121.778171 °
DWR ID	DWR_MA0005_01_s_2013_16				
Comment Code					
S3 : Repair the levee slope damaged by vehicle traffic and prevent access where possible.					
Inspector Comment

View of the unauthorized vehicle ramp on the landside slope.

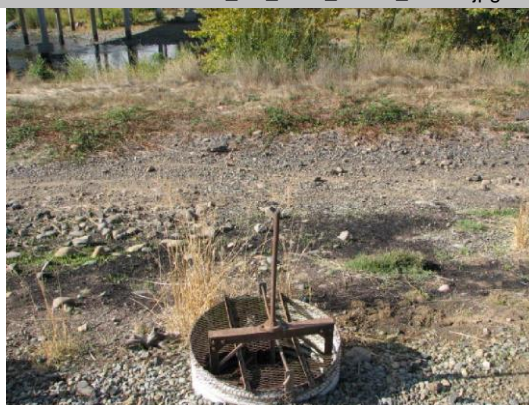
Photo 1 of 3 : UCIP_SP_2019_51949_67931.jpg

Comment Code						
Inspector Comment						
FS_ID:51949 DS_ID:1616 EP_NO: N/A Repair Type: No Action Needed Crossing Status: Found UCIP Comments: 5/15/2017 Crossing appears to be in good condition. LS inlet is located in the Distribution box on the LS toe. This is an overflow pipe used to regulate water levels in side the box. Pipe has been selected to be internally cleaned and inspected as part fo the DMP project. (DWR Sutter Yard- AFreitag)11/15/2016 Crossing appears to be in good condition. (DWR Sutter Yard- AFreitag)5/9/2016 Crossing appears to be in good condition.8/5/2015 WS pipe end is being overgrown by trees and other vegetation. Needs to be cleared back.12/8/2014 Same as last inspection.6/11/2014 Same as last inspection.11/20/2013 Same as last inspection.5/29/2013 Same as last inspection. FIELD_STRUCT_DESC: 24-inch corrugated metal drainage pipe through the levee, 16.5 feet below the crown. Slide gate in a corrugated metal riser on the waterside (WS) slope. Flap gate on the WS toe. Inlet on the landside (LS) toe, not found. [Additional Reference(s): DWR Levee Log, 1990 (HLM 3.95). USACE Sacramento O&M Manual, Unit 516 - Upper Butte Creek - Part No. 2, April 1960, (Station 381+36)]. FS Date: 5/31/2017 12:32:00 PM

CMP riser and slide gate on WS shoulder.

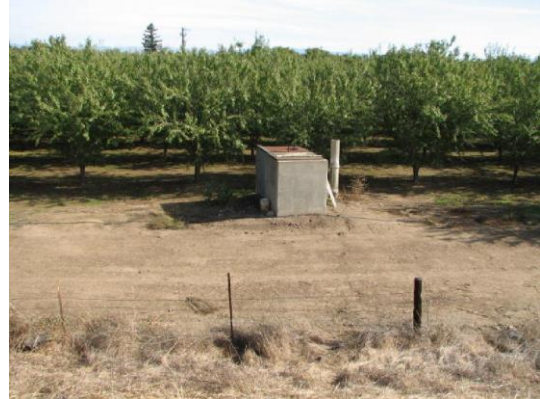
Photo 2 of 3 : UCIP_SP_2019_51949_67930.jpg

Unable to locate inlet on LS.

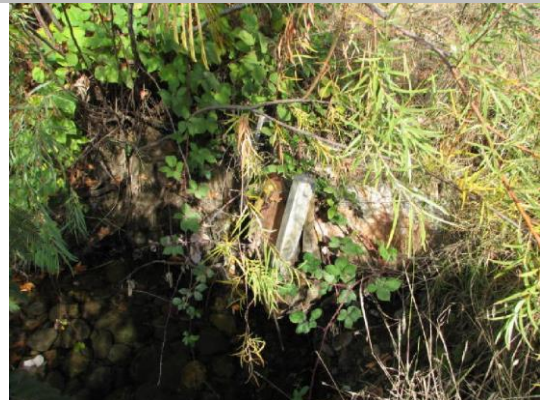
Photo 3 of 3 : UCIP_SP_2019_51949_67929.jpg

Flap gate in channel at WS toe.

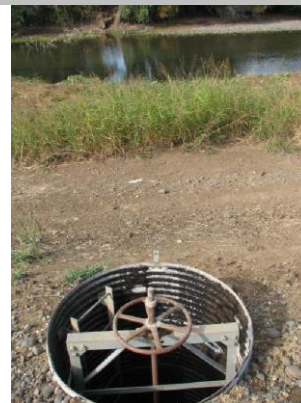
Photo 2 of 2 : UCIP_SP_2019_54040_67940.jpg

Comment Code						
Inspector Comment						
FS_ID:54040 DS_ID:1620 EP_NO: N/A Repair Type: Non-Urgent Crossing Status: Found UCIP Comments: 05/23/2019 (O. Magana - DWR UCIP)05/15/2017 Abandoned and needs to be done properly. A sink hole formed in the WS toe road and revealed the location of the WS pipe end. Sink hole will ned to be repaired before the next high water season but the pipe has been selected to be internally cleaned and camera inspected as part of the DMP project so it will have needed to be excavated along the WS end anyways. (DWR Sutter Yard- AFreitag)11/15/2016 Abandoned. Needs cover for the standpipe. (DWR Sutter Yard- AFreitag)05/09/2016 Abandoned pipe. Needs a cover for the standpipe.08/05/2015 Abandoned crossing. Covers need to be made for tops of standpipes to prevent falls.12/08/2014 Same as last inspection.06/11/2014 Same as last inspection.11/19/2013 Same as last inspection.05/29/2013 Same as last inspection. Land owner said pipes are abandoned and no longer used. Covers should be made for top of standpipe to prevent falls. Pipes should be properly abandoned.10/30/2012 Pipe 1/2 filled with soil at slide gate end. FIELD_STRUCT_DESC: *ABANDONED* 1 of 2: 36-inch drainage pipe through the levee, 11 feet below the crown. Slide gate in a 54-inch corrugated metal riser on the waterside (WS) slope. Concrete "U" headwall on the landside (LS). [Additional Reference(s): DWR Levee Log, 1990 (HLM 5.66). Sacramento O&M Manual, Unit 516 - Upper Butte Creek - Part No. 2, April 1960 (Station 470+00)]. FS Date: 5/23/2019 5:10:38 PM

54-inch CMP riser and slide gate on WS shoulder.

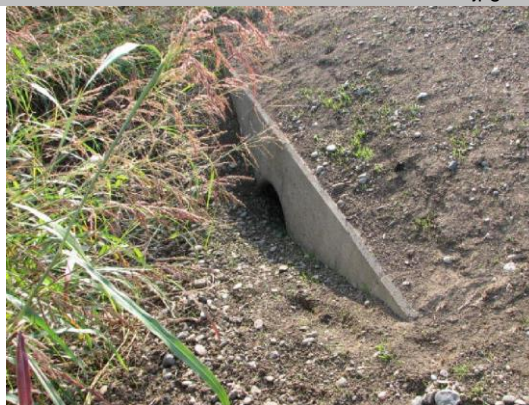
Photo 2 of 2 : UCIP_SP_2019_51970_67969.jpg

Comment Code						
Inspector Comment						
FS_ID:51970 DS_ID:1628 EP_NO: N/A Repair Type: Non-Urgent Crossing Status: Found UCIP Comments: 5/16/2017 LS inlet is almost completely buried. Nothing visible on the WS. Pipe has been selected to be internally cleaned and inspected as part of the DMP project. (DWR Sutter Yard-AFreitag)11/15/2016 Appears abandoned and should be done so properly. (DWR Sutter Yard-AFreitag)5/11/2016 Possibly an abandoned crossing. LS inlet was over 50% buried and nothing was found on the WS.8/4/2015 LS pipe end filled about 50% with soil and WS pipe end is buried.12/8/2014 Same as last inspection.6/11/2014 Same as last inspection.11/19/2013 Same as last inspection.5/29/2013 Same as last inspection.10/30/2012 Pipe filled with soil and outlet/appurtances are burried. FIELD_STRUCT_DESC: *ABANDONED* 24-inch corrugated metal drainage pipe through the levee, 8.5 feet below the crown. Flap gate on the waterside (WS). Concrete "U" shaped headwall on the landside (LS) toe. [Additional Reference(s): DWR Levee Log, 1990 (HLM 7.70). USACE Sacramento O&M Manual, Unit 515 - Upper Butte Creek - Part No. 1, April 1955, (Station 576+72), As-Built Drawing No. 50-4-2637, Exhibit B, Sheet 2, April 1950, (Station 576+72.4)]. FS Date: 5/31/2017 1:58:05 PM

Headwall at LS toe.

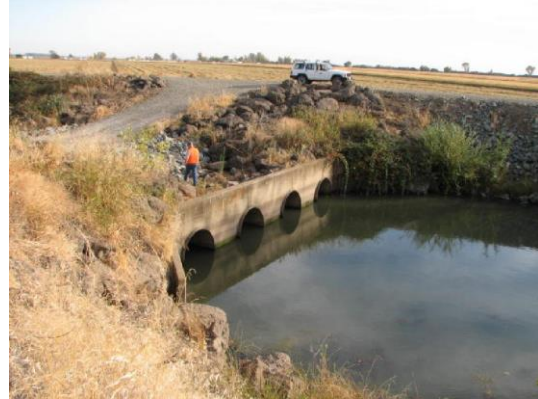
Photo 1 of 2 : UCIP_SP_2019_51977_67981.jpg

WS of crossing.

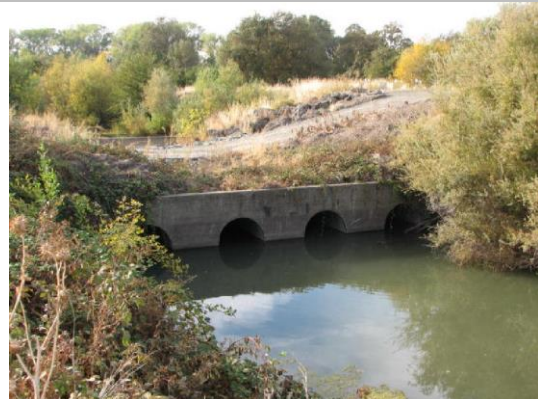
Photo 2 of 2 : UCIP_SP_2019_51977_67980.jpg

LS of crossing.

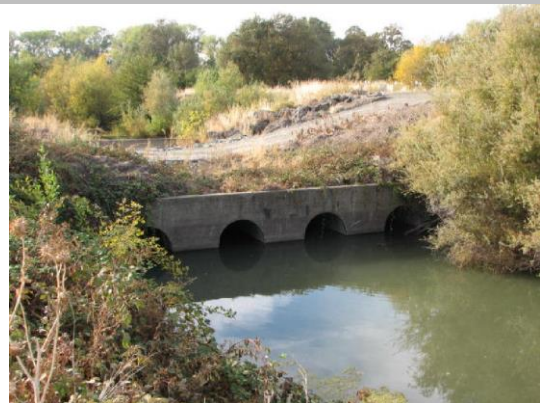
Photo 2 of 2 : UCIP_SP_2019_51979_67984.jpg

LS of crossing.

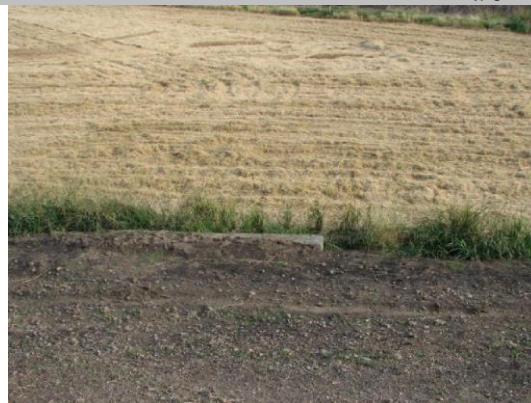
Photo 1 of 2 : UCIP_SP_2019_51982_67991.jpg

Concrete headwall at LS toe.

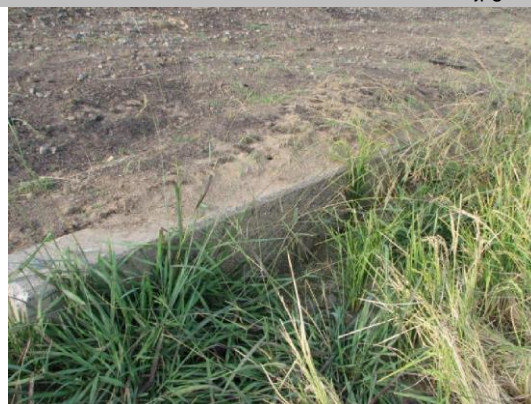
Photo 2 of 2 : UCIP_SP_2019_51982_67990.jpg

Concrete headwall at LS toe.

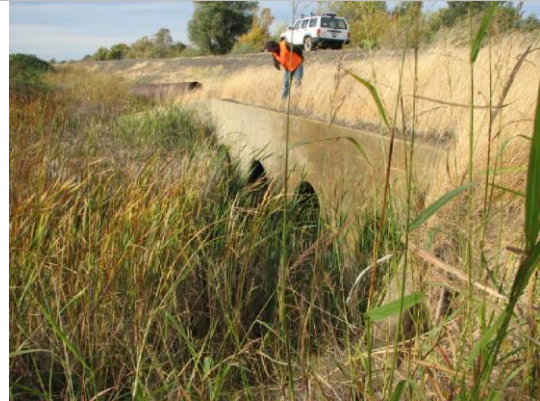
Photo 2 of 2 : UCIP_SP_2019_51990_68006.jpg

LS intake headwall.

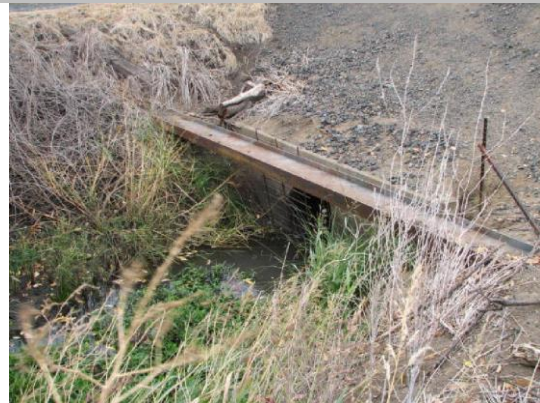
Photo 1 of 3 : UCIP_SP_2019_51999_68033.jpg

Headwall at inlet on LS toe.

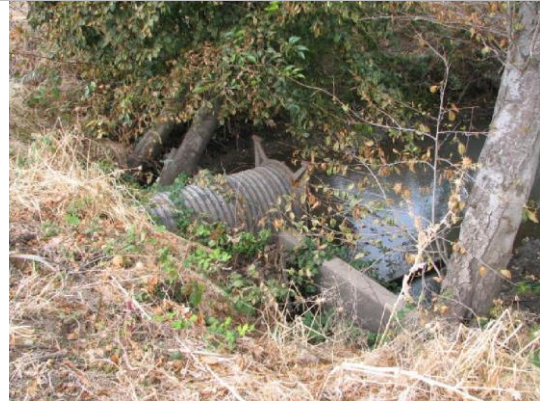
Photo 2 of 3 : UCIP_SP_2019_51999_68032.jpg

CMP pipe, flap gate, and headwall on WS toe.

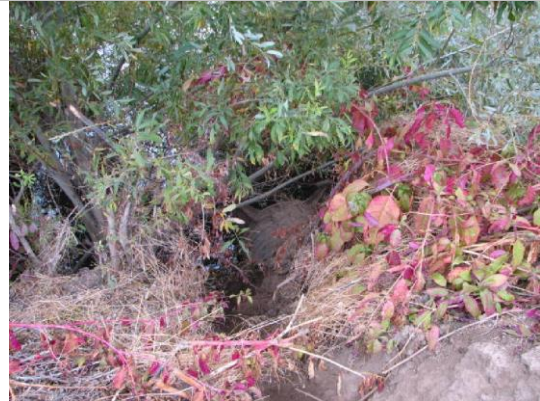
Photo 1 of 3 : UCIP_SP_2019_53009_68497.jpg

FIELD_STRUCT_DESC: 36-inch corrugated metal drainage pipe through the levee, 17 feet below the crown. Flap gate on the waterside (WS). Slide gate on the landside (LS) toe. Concrete headwalls at both the LS and the WS toes. [Additional Reference(s): DWR Levee Log, 1990. USACE Sacramento O&M Manual 515, (Station 902+50). USACE As-Built Drawing No. 50-4-2637, Exhibit B, Sheet 5, April 1950, (Station 902+50)].
FS Date: 10/5/2018 11:20:19 AM

Flap gate on WS slope.

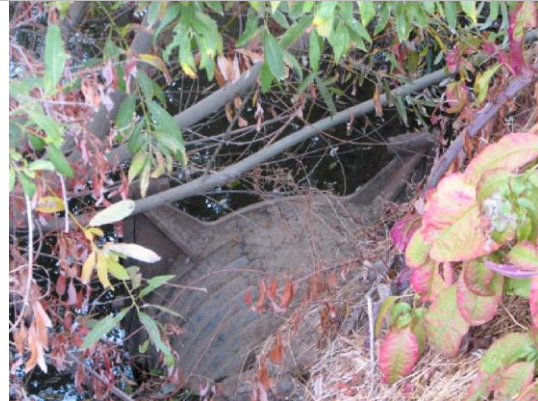
Photo 2 of 3 : UCIP_SP_2019_53009_68496.jpg

FS_ID:53009
DS_ID:1645
EP_NO: N/A
Repair Type: Urgent
Crossing Status: Found
UCIP Comments: 10/5/2018 Unable to see pipe on waterside due to high water level in the creek. Erosion is present around headwall on LS. Screw gate on LS blocked with silt approximately halfway in height. (O.Yakimov - DWR) 5/18/2017 LS erosion still present. Ws flap gate has been completely buried by sediment after the high water flows through the area. Pipe has been selected to be internally cleaned and inspected as part of the DMP project. (DWR Sutter Yard- AFreitag)11/14/2016 LS erosion still present and is into the prism of the levee. WS flap gate was still mostly buried and non-operational. (DWR Sutter Yard- AFreitag)5/23/2016 The tree that was overgrowing the WS flapgate has been removed. Flap gate was half buried and unable to open. Erosion on the LS is still present. (DWR Sutter Yard - afreitag)7/28/2015 LS inlet is underwater but there appears to be erosion behind the LS headwall. WS pipe end and flap gate are completely overgrown and inaccessible for inspection. (DWR Sutter Yard - afreitag)11/25/2014 Tree is overgrowing the WS pipe outlet.. Needs to be trimmed back. (DWR Sutter Yard - afreitag)6/4/2014 Same as last inspection. (DWR Sutter Yard - afreitag)11/12/2013 Same as last inspection. (DWR Sutter Yard - afreitag)6/6/2013 Same as last inspection. (DWR Sutter Yard - afreitag)10/31/2012 Vegetation needs to be cleared from outlet. (DWR UCIP - wwylie)

Flap gate on WS slope.

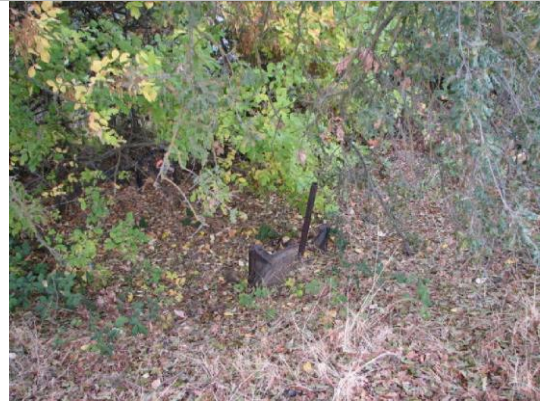
Photo 3 of 3 : UCIP_SP_2019_52014_68062.jpg

Comment Code						
Inspector Comment						
FS_ID:52014 DS_ID:1647 EP_NO: N/A Repair Type: No Action Needed Crossing Status: Found UCIP Comments: 5/18/2017 Crossing appears to be in good condition. Tree near the LS screw gate could use some trimming. Pipe has been selected to be internally cleaned and inspected as part of the DMP project. (DWR Sutter Yard- AFreitag)11/14/2016 Crossing appears to be in good condition. (DWR Sutter Yard- AFreitag)5/23/2016 Crossing appears to be in good condition.7/28/2015 Pipe appears in good condition. No noticeable issues to report.6/6/2013 Same as last inspection.11/12/2013 Same as last inspection.6/04/2014 Same as last inspection.11/25/2014 Same as last inspection. FIELD_STRUCT_DESC: 30-inch corrugated metal drainage pipe through the levee, 14.3 feet below the crown. Slide gate on the landside (LS). Flap gate on the waterside (WS). Concrete headwall at the LS toe. Concrete splash apron on the WS. [Additional Reference(s): DWR Levee Log, 1990. USACE Sacramento O&M Manual 515, April 1955, (Station 5+20""A""). USACE As-Built Drawing No. 50-4-2637, Exhibit B, Sheet 4, April 1950, (Station 5+20""A"").] FS Date: 6/1/2017 9:47:13 AM

Flap gate at outlet on WS berm.

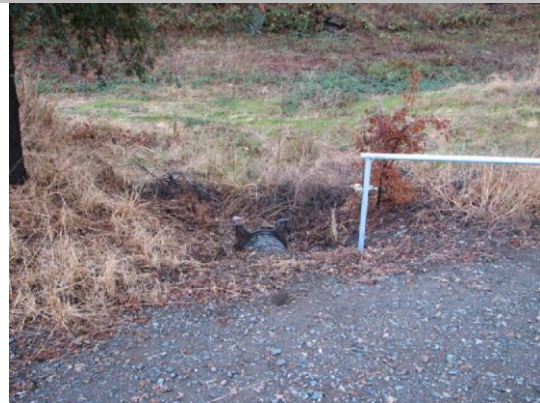
Photo 1 of 3 : UCIP_SP_2019_52049_68122.jpg

Comment Code						
Inspector Comment						
FS_ID:52049 DS_ID:1654 EP_NO: N/A Repair Type: No Action Needed Crossing Status: Found UCIP Comments: 5/18/2017 Crossing appears to be in good condition. Pipe has been selected to be internally cleaned and inspected as part of the DMP project. (DWR Sutter Yard- A/Freitag)11/14/2016 Crossing appears to be in good condition. (DWR Sutter Yard- A/Freitag)5/23/2016 Crossing appears to be in good condition. 7/28/2015 Crossing appears in good condition. No noticeable issues to report. 11/24/2014 Same as last inspection. 6/04/2014 Same as last inspection. 11/12/2013 Same as last inspection. 6/6/2013 Same as last inspection. FIELD_STRUCT_DESC: 24-inch corrugated metal drainage pipe through the levee, 9.4 feet below the crown. Flap gate on the waterside (WS). Concrete headwalls at both the landside (LS) and the WS toes. [Additional Reference(s): DWR Levee Log, 1990. USACE Sacramento O&M Manual 515, April 1955, (Station 627+00). USACE As-Built Drawing No. 50-4-2637, Exhibit B, Sheet 3, April 1950, (Station 627+00)]. FS Date: 6/1/2017 1:10:07 PM

Flap gate on WS toe.

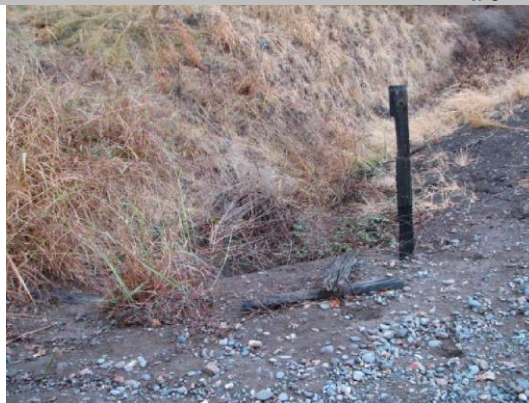
Photo 2 of 3 : UCIP_SP_2019_52049_68121.jpg

Headwall on LS toe.

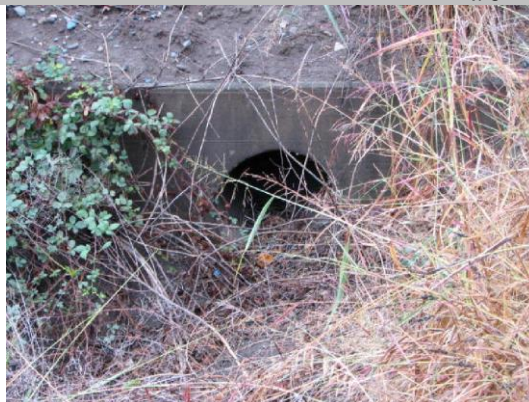
Photo 3 of 3 : UCIP_SP_2019_52049_68120.jpg

Headwall on LS toe.

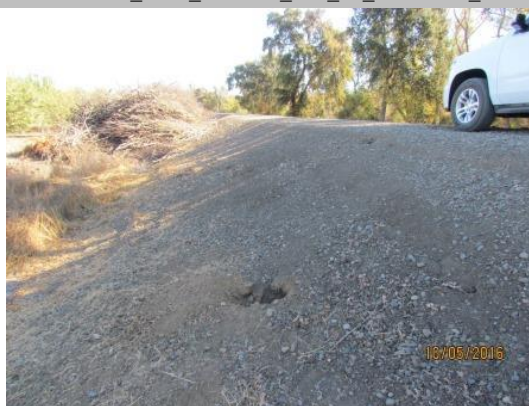
Photo 1 of 2 : SP_2019_MA0005_197_53_20190327_00025.jpg

View of the rodent holes along the landside slope.

LM Start	7.74	Rating **	U	Issue No.	53
LM End	7.74	Issue Type +	Ma	Location *	LS
Category	Earthen Levee			GPS Latitude/Longitude	
				Start	End
Item	Animal Control			39.605088 °	39.605088 °
				-121.788569 °	-121.788569 °
DWR ID	DWR_MA0005_02_f_2016_53				
Comment Code					
A1 : Exterminate rodents and backfill and compact or grout burrows.					
Inspector Comment

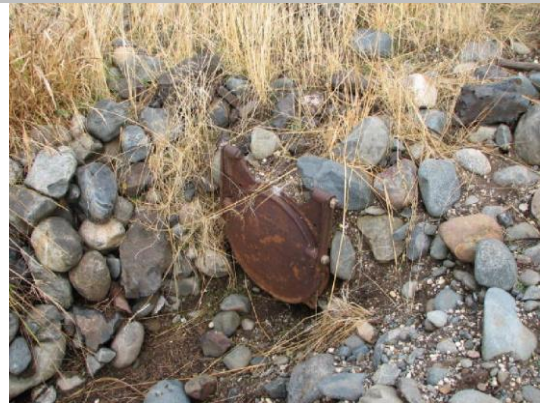
Photo 1 of 2 : UCIP_SP_2019_52052_68129.jpg

Comment Code					
Inspector Comment					
FS_ID:52052 DS_ID:1656 EP_NO: N/A Repair Type: Non-Urgent Crossing Status: Found UCIP Comments: 5/18/2017 LS inlet is almost completely full of soil. Pipe has been selected to be internally cleaned and inspected as part of the DMP project. (DWR Sutter Yard- A/Freitag)11/14/2016 LS inlet almost completely full of soil. (DWR Sutter Yard- A/Freitag)5/23/2016 LS end is almost completel full of soil.7/28/2015 Pipe is still over 3/4 full of soil. 11/24/2014 Same as last inspection.6/04/2014 Same as last inspection.11/12/2013 Same as last inspection.6/6/2013 Same as last inspection.10/31/2012 Pipe 3/4 full with soil on LS. FIELD_STRUCT_DESC: 24-inch (not 18-inch as shown in as-built drawing) corrugated metal drainage pipe through the levee, 6.7 feet below the crown. Concrete headwall at the landside (LS) toe. Flap gate on the waterside (WS). [Additional Reference(s): DWR Levee Log, 1990. USACE Sacramento O&M Manual 516, April 1960, (Station 379+98). USACE As-Built Drawing No. 50-4-2637, Exhibit B, Sheet 2, April 1950, (Station 550+60)]. FS Date: 6/1/2017 1:15:55 PM

Flap gate at WS toe.

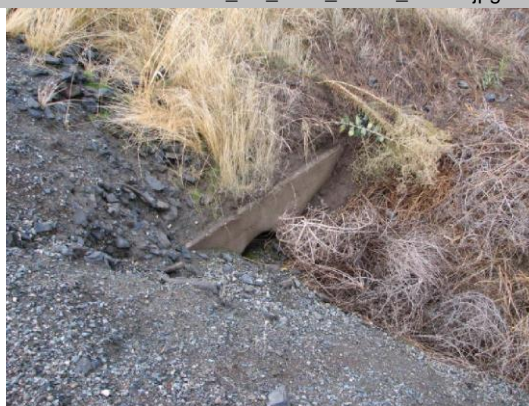
Photo 2 of 2 : UCIP_SP_2019_52052_68128.jpg

Concrete headwall on LS toe.

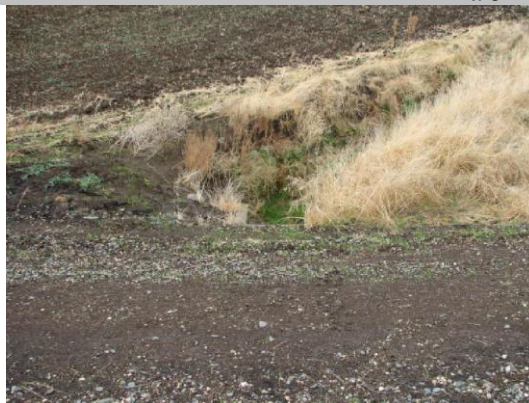
Photo 1 of 3 : UCIP_SP_2019_52059_68394.jpg

Comment Code					
Inspector Comment					
FS_ID:52059 DS_ID:1662 EP_NO: N/A Repair Type: No Action Needed Crossing Status: Found UCIP Comments: 5/18/2017 Crossing appears to be in good condition. Pipe has been selected to be internally cleaned and inspected as part of the DMP project. (DWR Sutter Yard- AFreitag)11/14/2016 Crossing appears to be in good condition. (DWR Sutter Yard- AFreitag)5/12/2016 Crossing appears to be in good condition.7/30/2015 Crossing is in good condition. No noticeable issues to report.11/24/2014 Same as last inspection.6/4/2014 Same as last inspection.11/13/2013 Same as last inspection. .6/6/2013 Same as last inspection. FIELD_STRUCT_DESC: 30-inch corrugated metal drainage pipe through the levee, 16.3 feet below the crown. Flap gate on the waterside (WS). Concrete ""U"" shaped headwalls on both the landside (LS) and the WS. [Additional Reference(s): DWR Levee Log, 1990. USACE Sacramento O&M Manual 516, April 1960, (Station 374+90). USACE As-Built Drawing No. 50-4-3367, Exhibit B, Sheet 13, April 1957, (Station 374+90)]. FS Date: 6/1/2017 1:25:58 PM

Concrete inlet on LS toe.

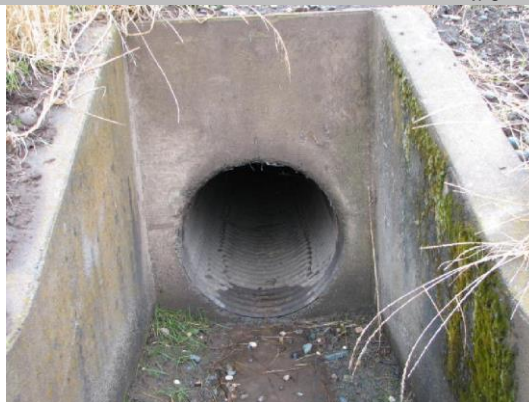
Photo 2 of 3 : UCIP_SP_2019_52059_68393.jpg

Concrete inlet on LS toe.

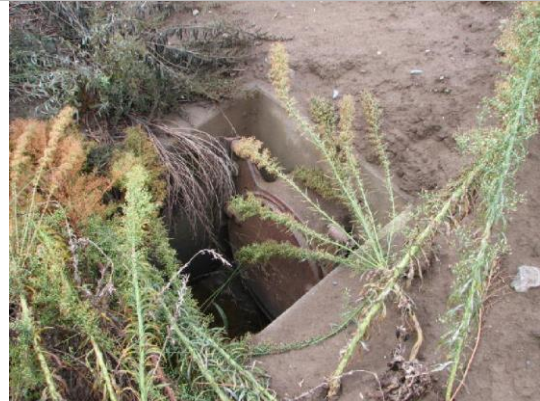
Photo 3 of 3 : UCIP_SP_2019_52059_68392.jpg

Concrete outlet and flap gate on WS toe.

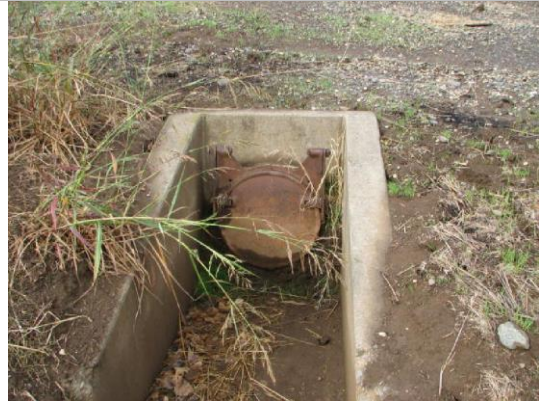
Photo 3 of 3 : UCIP_SP_2019_52062_68403.jpg

Concrete U shaped headwall and flap gate at WS toe.

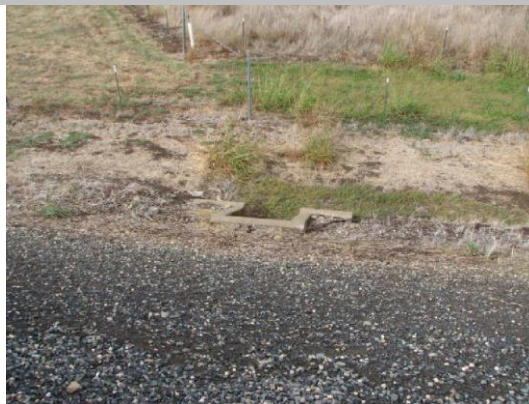
Photo 2 of 3 : UCIP_SP_2019_52063_68412.jpg

Concrete U shaped headwall on LS toe.

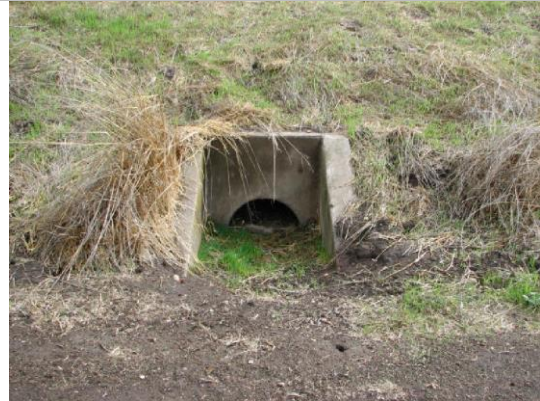
Photo 3 of 3 : UCIP_SP_2019_52064_68415.jpg

Comment Code						
Inspector Comment						
FS_ID:52064 DS_ID:1666 EP_NO: N/A Repair Type: Non-Urgent Crossing Status: Found UCIP Comments: 5/18/2017 LS inlet half full of soil and WS flap gate half buried by sediment. Pipe has been selected to be internally cleaned and inspected as part of the DMP project. (DWR Sutter Yard-AFreitag)11/14/2016 LS pipe inlet is half full of soil. WS flap gate shut but half buried by sediment. (DWR Sutter Yard-AFreitag)5/12/2016 Pipe is half full of soil.7/30/2015 Pipe is 1/4 to 1/2 full of soil still.11/24/2014 Same as last inspection.6/4/2014 Same as last inspection.11/13/2013 Same as last inspection.6/6/2013 Same as last inspection.11/01/2012 Pipe 1/2 filled with soil. FIELD_STRUCT_DESC: 24-inch corrugated metal drainage pipe through the levee, 11.2 feet below the crown. Flap gate on the waterside (WS). Concrete ""U"" shaped headwalls on both the landside (LS) and the WS. [Additional Reference(s): DWR Levee Log, 1990. USACE Sacramento O&M Manual 516, April 1960, (Station 304+10). USACE As-Built Drawing No. 50-4-3367, Exhibit B, Sheet 3, April 1957, (Station 304+10)]. FS Date: 6/1/2017 1:34:12 PM

Concrete U-shaped headwall on LS toe.

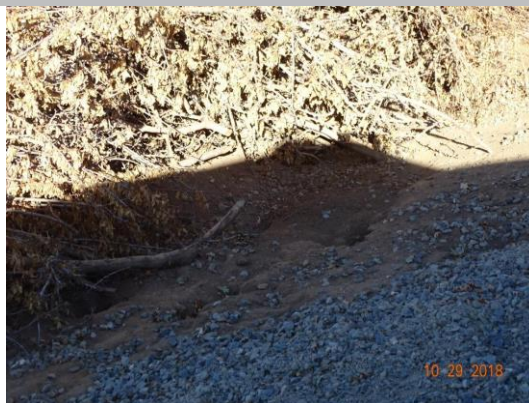
Photo 1 of 1 : SP_2019_MA0005_197_71_20190327_00039.jpg

LM Start	11.77	Rating **	M	Issue No.	71
LM End	11.77	Issue Type +	Ma	Location *	LS
Category	Earthen Levee			GPS Latitude/Longitude	
				Start	End
Item	Animal Control			39.657115 °	39.657115 °
				-121.788703 °	-121.788703 °
DWR ID	DWR_MA0005_02_f_2018_71				
Comment Code					
A3 : No rodents visible, but rodent burrows visible; need to backfill and compact or grout burrows.					
Inspector Comment

View of the rodent holes along the landside slope.

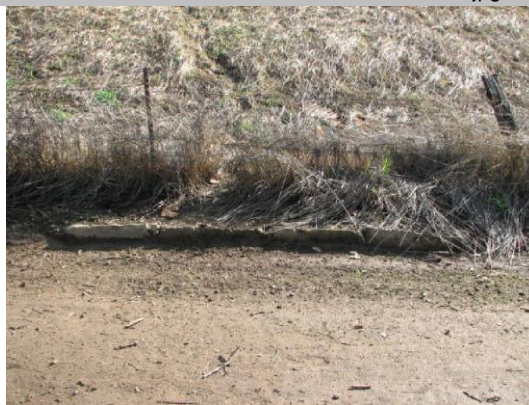
Photo 2 of 3 : UCIP_SP_2019_54048_68464.jpg

FS_ID:54048
DS_ID:1673
EP_NO: N/A
Repair Type: Non-Urgent
Crossing Status: Found
UCIP Comments: 05/23/2019 (O. Magana - DWR UCIP)05/18/2017 Abandoned- needs to be done properly. Pipe has been selected to be internally cleaned and inspected as part of the DMP project. (DWR Sutter Yard- A Freitag)11/14/2016 Abandoned- needs a cover for standpipe. (DWR Sutter Yard- A Freitag)05/11/2016 Abandoned crossing. Needs a cover to the WS riser.08/03/2015 Crossing appears abandoned. Only the slide gate inside riser on the WS shoulder could be found. Riser needs a cover made for it.11/24/2014 Same as last inspection.06/04/2014 Same as last inspection.11/13/2013 Slide gate top and stem were repaired to make gate operational.06/06/2013 New slidegate is planned to be installed during summer of 2013.11/01/2012 Slide gate on WS shoulder bent and damaged (inoperable) Pipe appears abandoned.
FIELD_STRUCT_DESC: *ABANDONED* 24-inch corrugated metal drainage pipe through the levee, 14 feet below the crown. Slide gate in a corrugated metal riser on the waterside (WS) slope. [Additional Reference(s): DWR Levee Log, 1990. USACE Sacramento O&M Manual 516, April 1960, (Station 126+91)].

Abandoned headwall on LS toe.

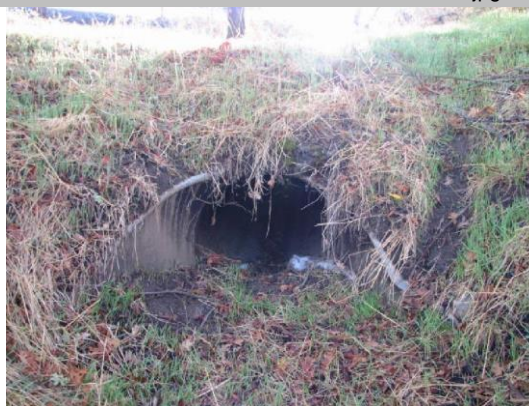
Photo 2 of 3 : UCIP_SP_2019_52083_68530.jpg

Inlet 50-feet NW of levee crown.

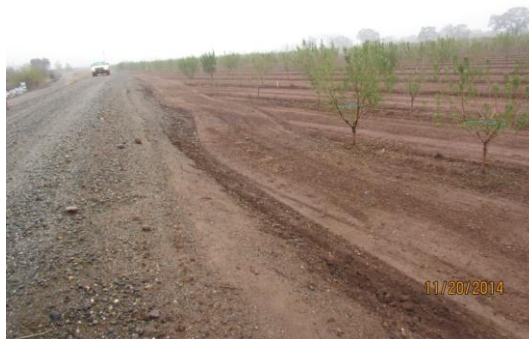
Photo 1 of 1 : SP_2019_MA0005_197_43_20190327_00019.jpg

LM Start	14.13	Rating **	M	Issue No.	43
LM End	14.13	Issue Type +	Ma	Location *	LS
Category	Earthen Levee			GPS Latitude/Longitude	
				Start	End
Item	Slope Stability			39.688715 °	39.688715 °
				-121.778345 °	-121.778345 °
DWR ID	DWR_MA0005_02_f_2014_43				
Comment Code					
S1 : Repair slope instability.					
Inspector Comment					
The landowner disked into the slope of the levee.

View of the tilling into the landside slope.

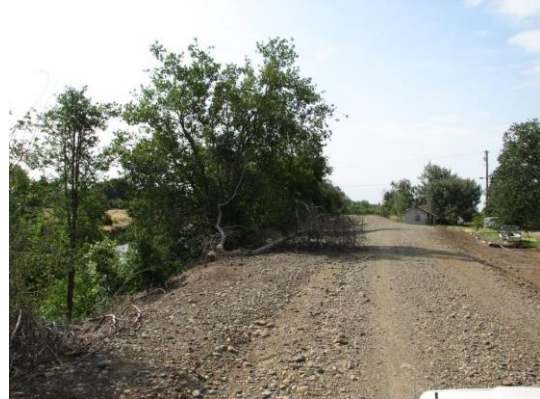
Photo 1 of 1 : SP_2019_MA0005_197_38_20190327_00014.jpg

5/5/2016: Remove fallen tree from WS slope.

LM Start	14.39	Rating **	M	Issue No.	38
LM End	14.39	Issue Type +	Ma	Location *	WS
Category	Earthen Levee			GPS Latitude/Longitude	
				Start	End
Item	Encroachments			39.692284 °	39.692284 °
				-121.779394 °	-121.779394 °
DWR ID	DWR_MA0005_02_s_2016_38				
Comment Code					
TR : Tree or limb					
Inspector Comment					
Remove the fallen trees from the waterside slope.

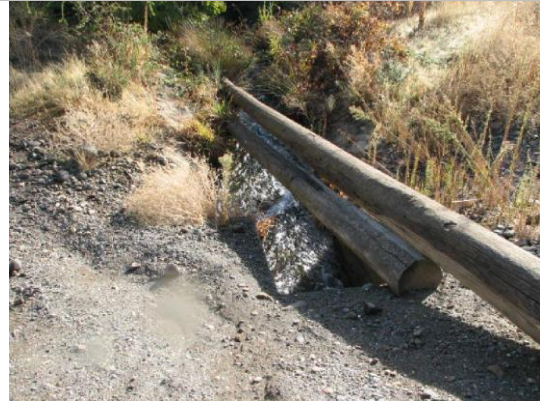
Photo 1 of 3 : UCIP_SP_2019_54049_68544.jpg

Comment Code					
Inspector Comment					
FS_ID:54049 DS_ID:1682 EP_NO: N/A Repair Type: No Action Needed Crossing Status: Found UCIP Comments: 05/23/2019 (O. Magana - DWR UCIP)05/18/2017 Crossing appears to be in good condition. Pipe has been selected to be internally cleaned and inspected as part of the DMP project. (DWR Sutter Yard- A Freitag)11/14/2016 Crossing appears to be in good condition. (DWR Sutter Yard- A Freitag)05/11/2016 Crossing appears to be in good condition.08/03/2015 Crossing appears in good condition. No noticeable issues to report.11/25/2014 Same as last inspection.06/04/2014 Same as last inspection.11/13/2013 Same as last inspection.06/06/2013 Same as last inspection. FIELD_STRUCT_DESC: 24-inch corrugated metal drainage pipe through the levee, 7.2 feet below the crown. Concrete "U" shaped headwall and grouted spillway on the waterside (WS). Slide gate in a 48-inch concrete standpipe on the landside (LS). Flap gate on the WS. [Additional Reference(s): DWR Levee Log, 1990. USACE Sacramento O&M Manual 516, April 1960, (Station 37+10)]. FS Date: 5/23/2019 5:21:51 PM

Outlet at U-shaped headwall on WS toe.

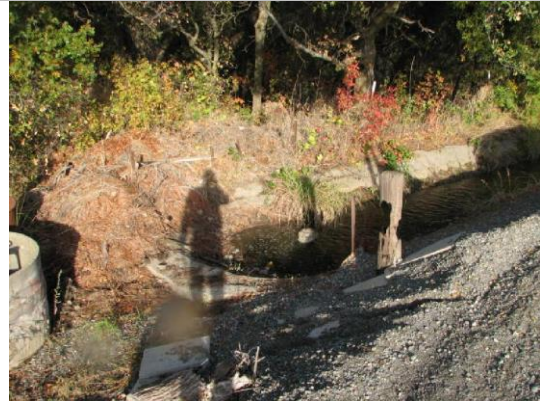
Photo 2 of 3 : UCIP_SP_2019_54049_68543.jpg

Concrete lined channel on LS toe.

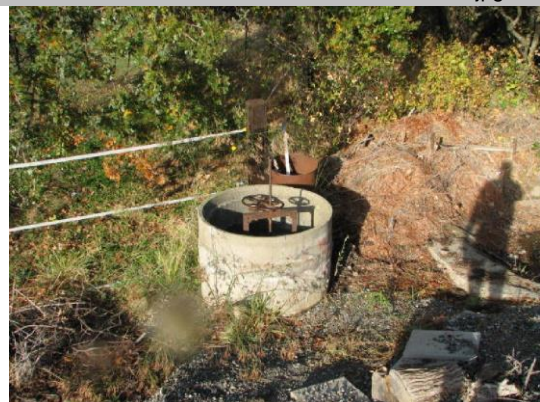
Photo 3 of 3 : UCIP_SP_2019_54049_68542.jpg

Concrete standpipe and slide gate on LS toe.
